# STRUCTURAL INSPECTION REPORT

24 Roxbury Road  
New Britain, CT 06053

Inspecting Firm: Taddonio Engineering, LLC

Date of Inspection: January 11, 2024

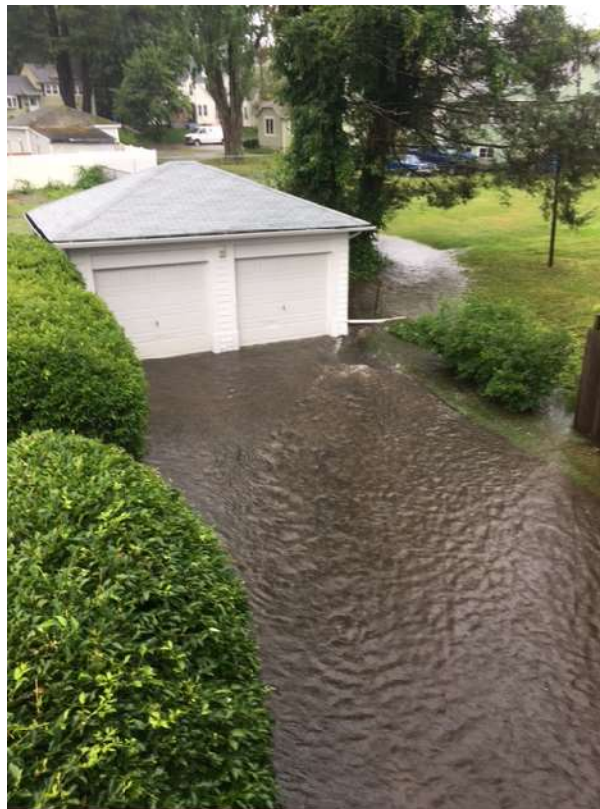
The area around the house has a well documented history of severe flooding during heavy rain events. The pictures provided by homeowner, show that the water channels from behind that house and travels to the retention pond area across the street in front of the house. The channel connecting the areas behind and in front of the house travels through the driveway area, along the right side of house. There is also flooding in the area to the left of the house as well. The movement of water in and around the foundation can cause erosion of the supporting soil near the foundation. When enough soil is eroded away, the foundation will settle and shift. The defects and movement seen in the foundation is believed to be the direct result of this flowing flood water. There are no other obvious causes for the defects seen. The fact that the right wall has the tilting and other walls do not, coincide with the flowing water along the right wall. The surface flood water needs to be controlled in order to stop the further progression of movement in the foundation. The long term effects can be structurally compromising to the foundation and structure above.

View of flood water traveling through the driveway from behind the house.

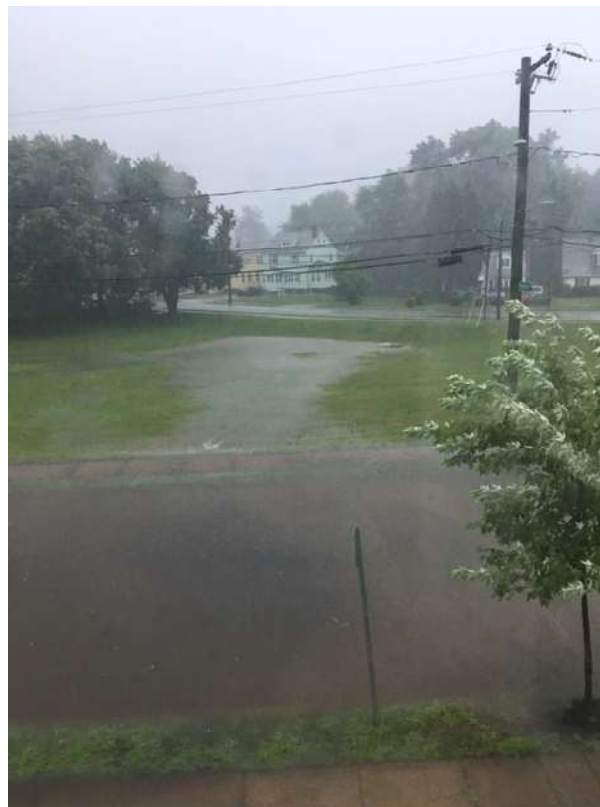
View of water travelling over street to retention area in front.

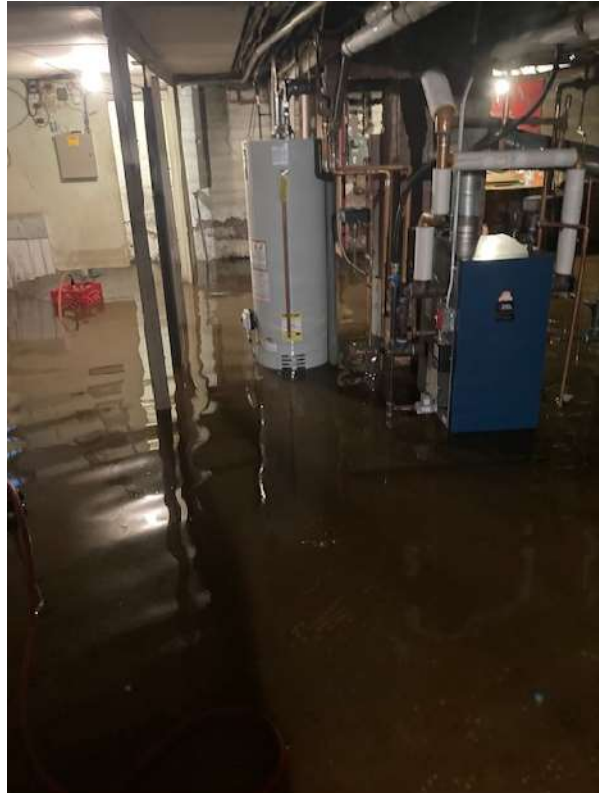
View of standing water flooding basement.

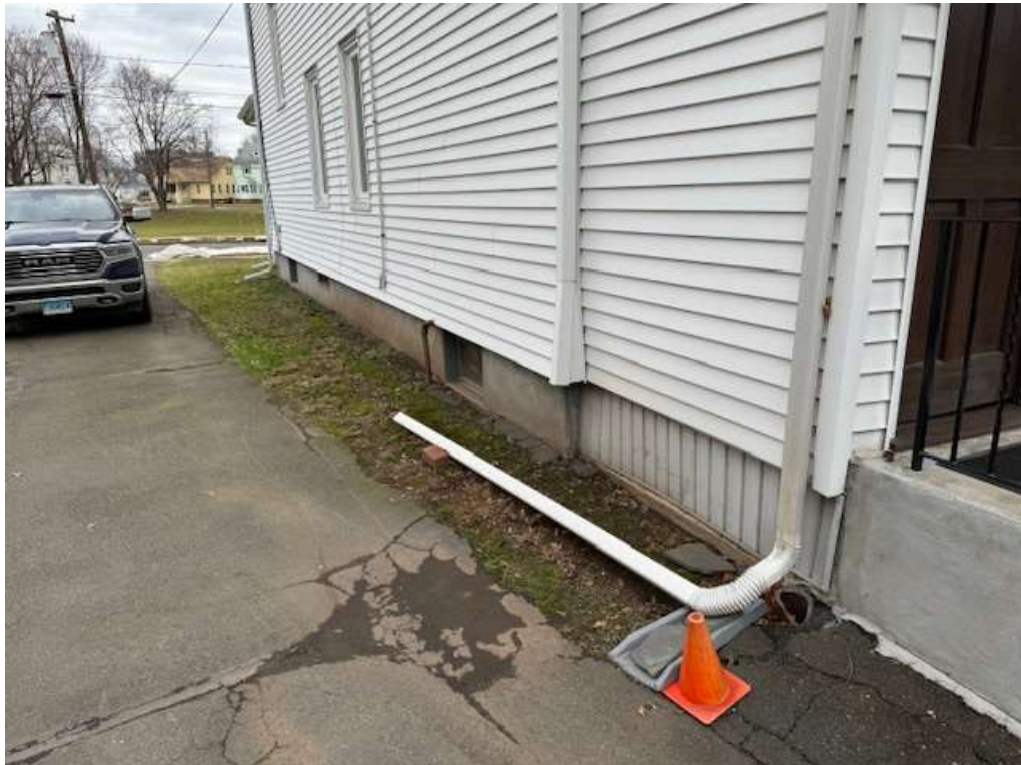
View of right foundation wall.

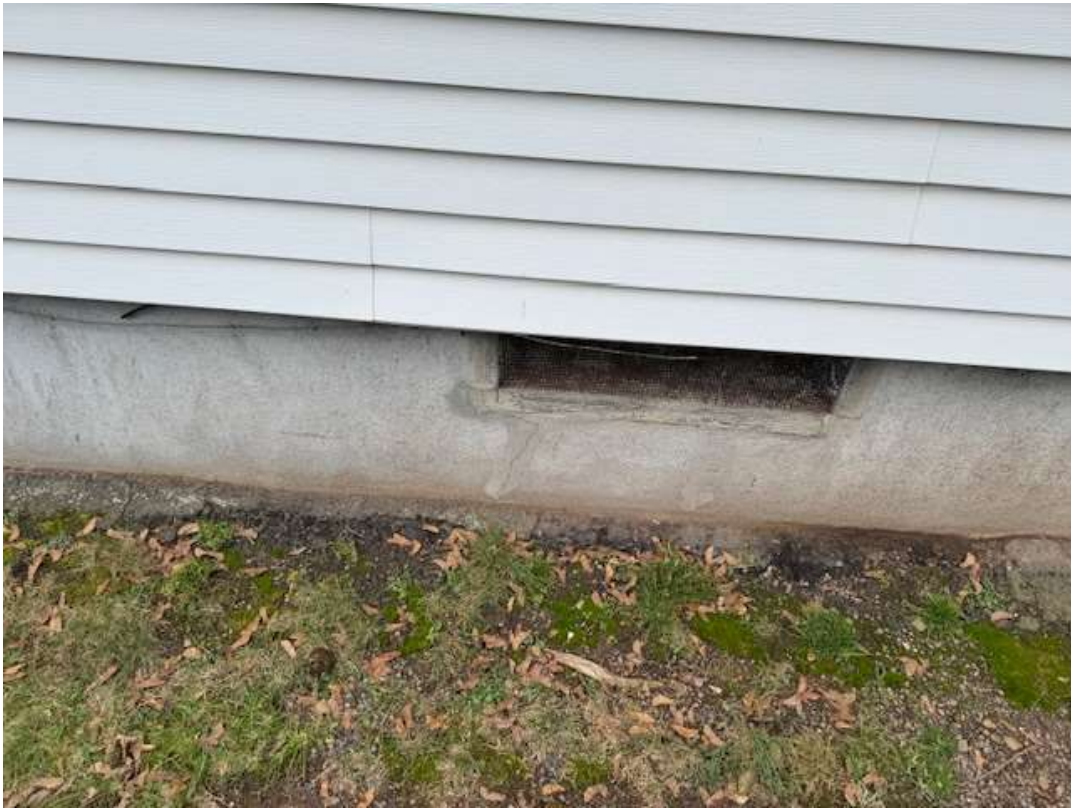
-There are several settlement cracks in the walls of the foundation visible from the exterior and interior sides. There are also cracks in the floor slab of the basement.

View of settlement crack in right wall.

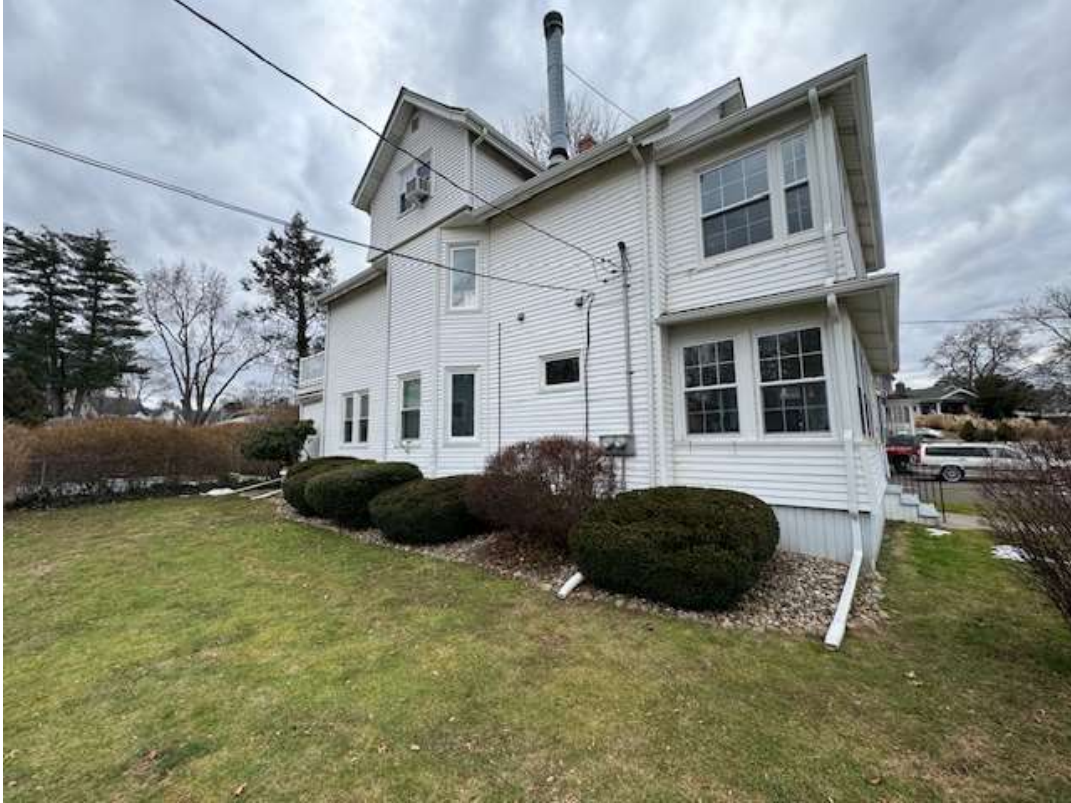
View of left side of house.

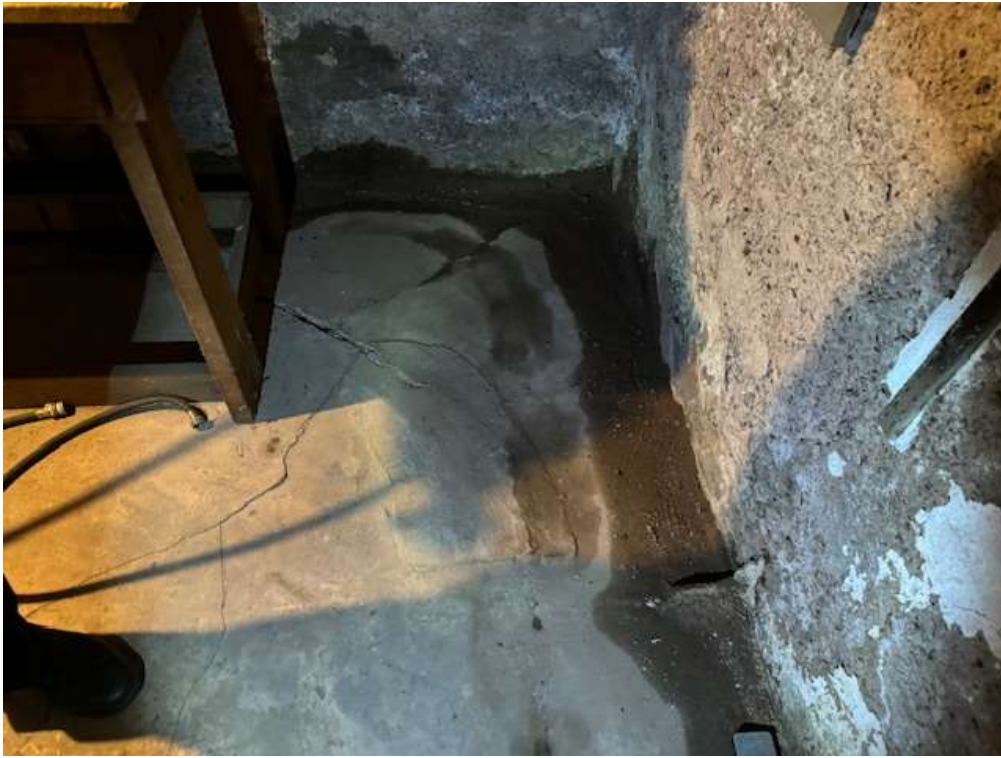
View of basement floor slab with cracking and dampness.

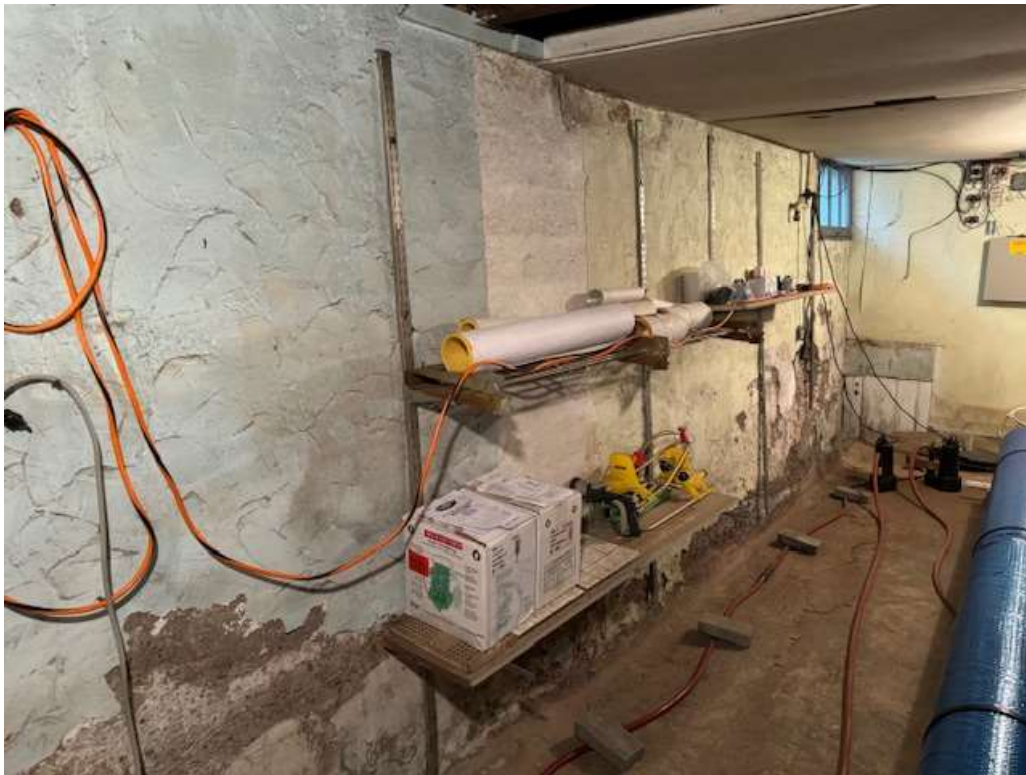
-The right wall of the foundation has a noticeable outward tilt when viewing from inside the basement. The tilt appears minor at the current time but it is unclear when the movement started.

View of inside face of right wall with outward tilt.

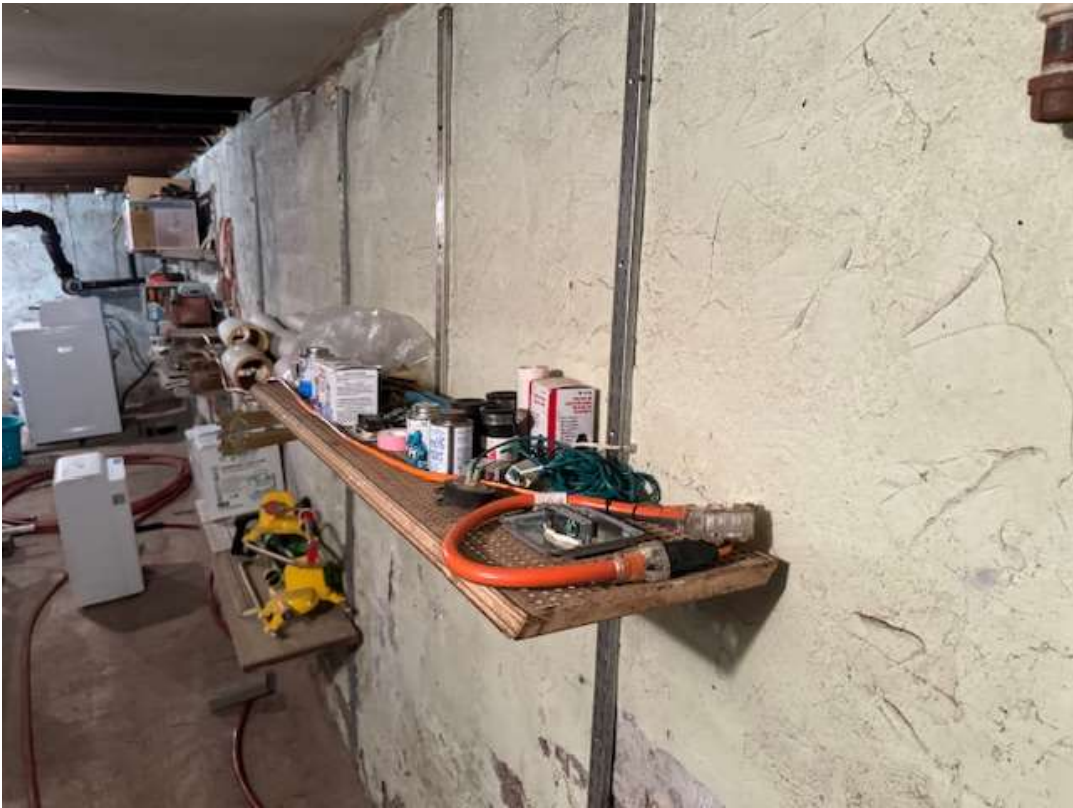
View of tilt in right foundation wall.
